Onondaga County Health Department

Incinerator Monitoring Program

2008 Summary Report

December 18, 2009

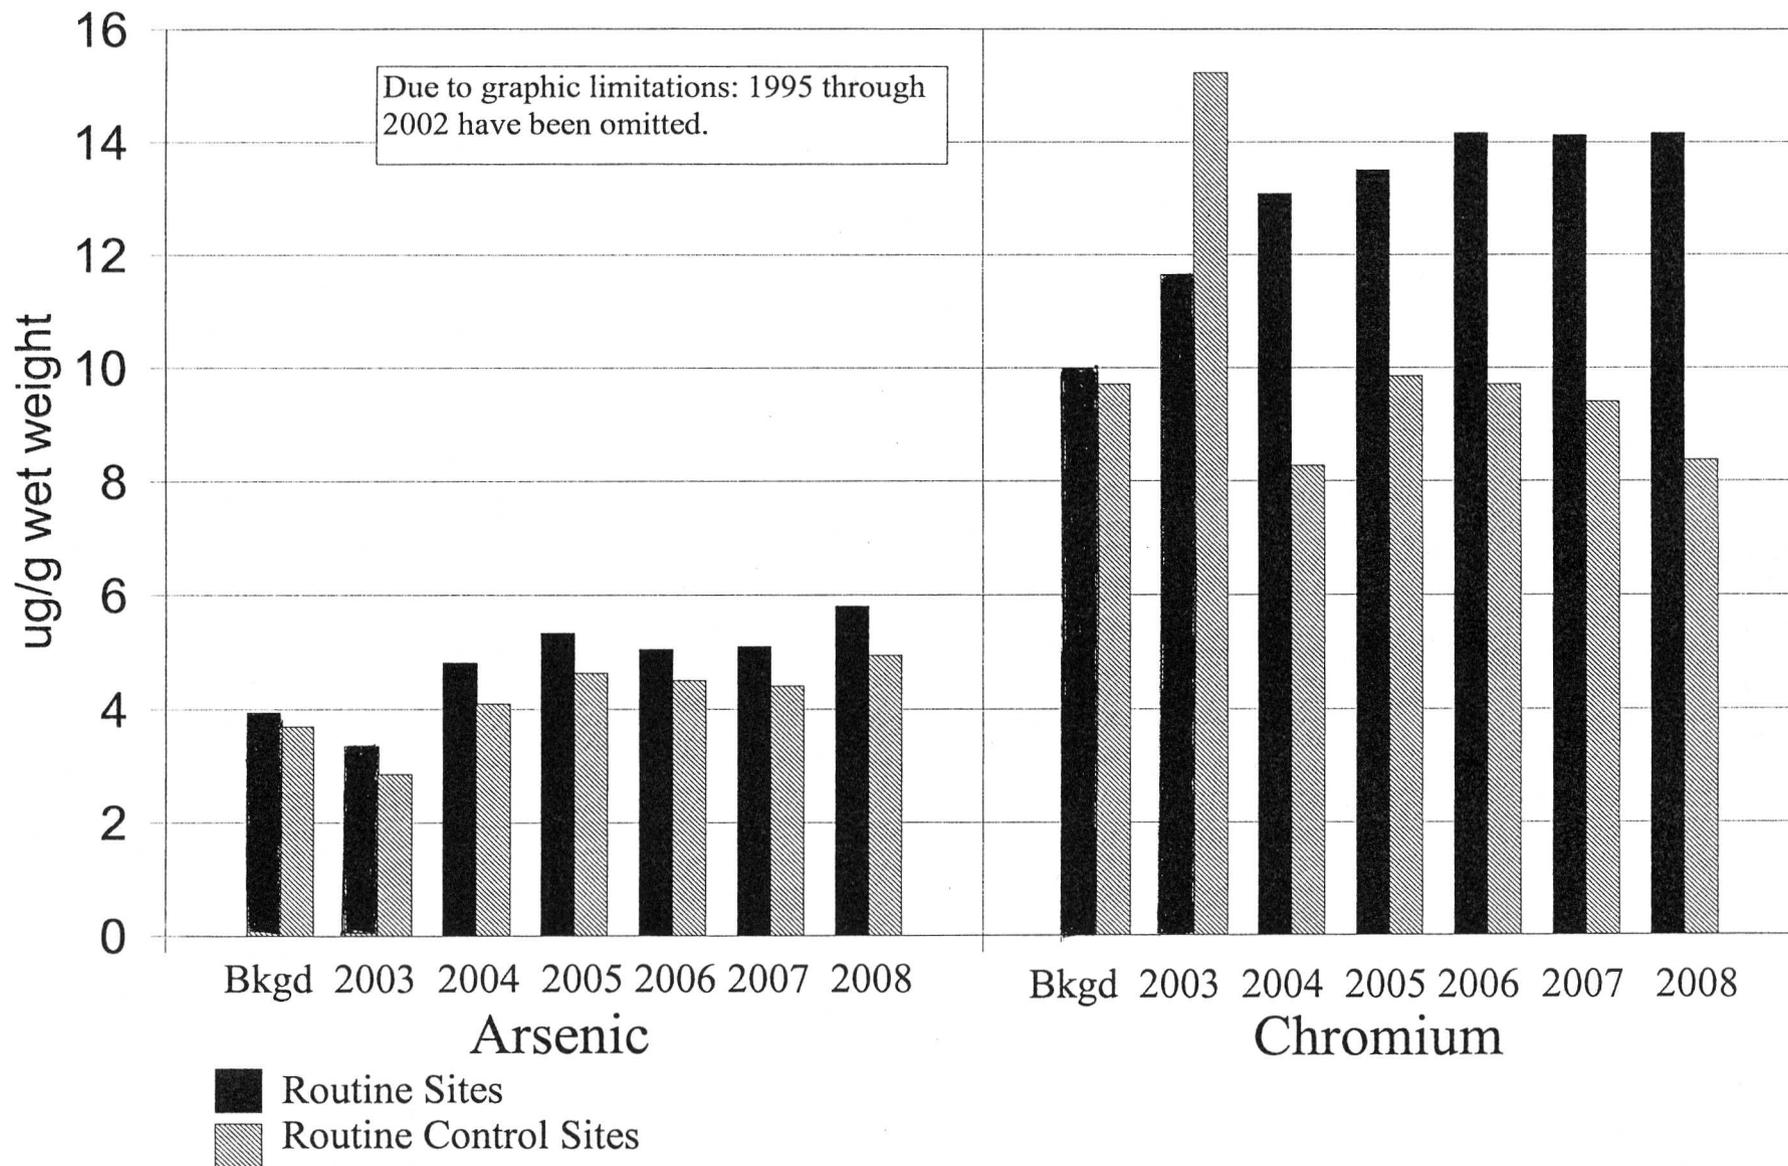
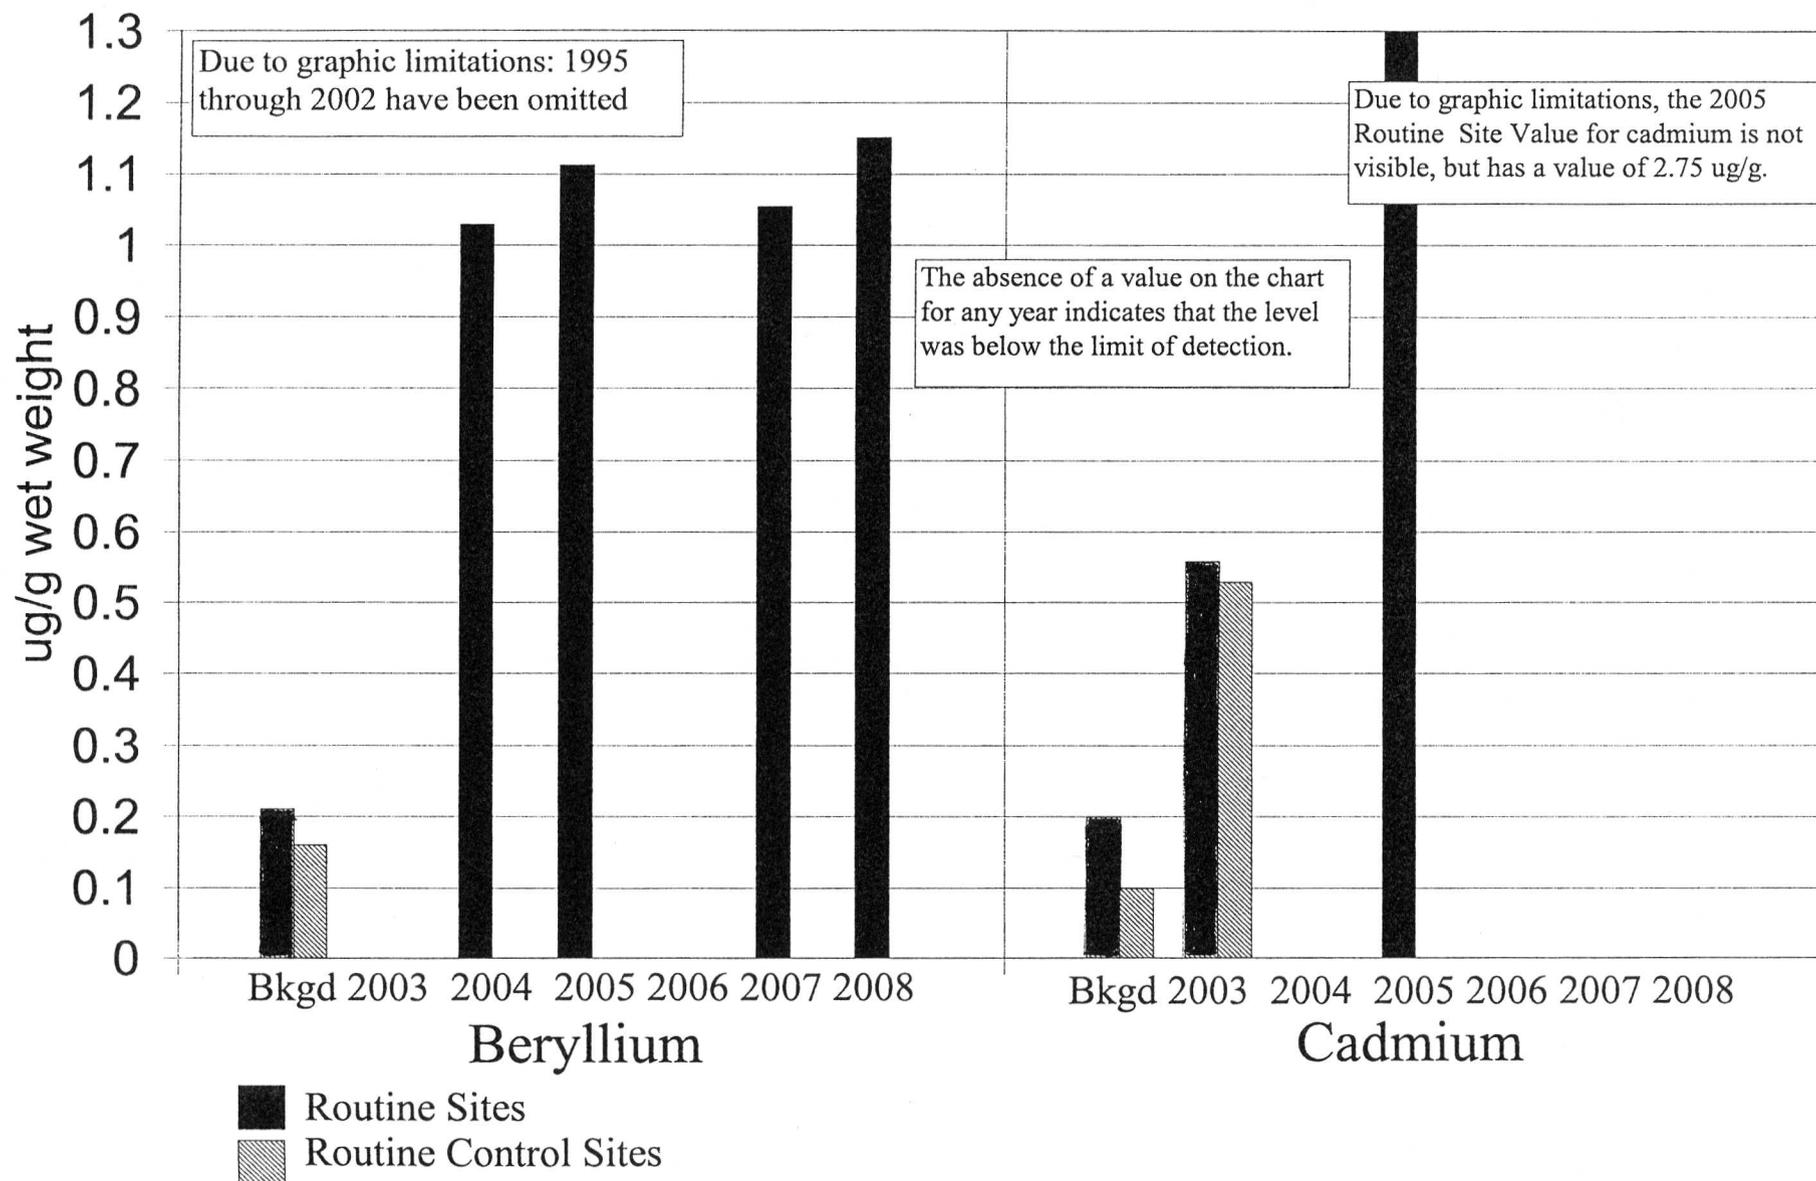
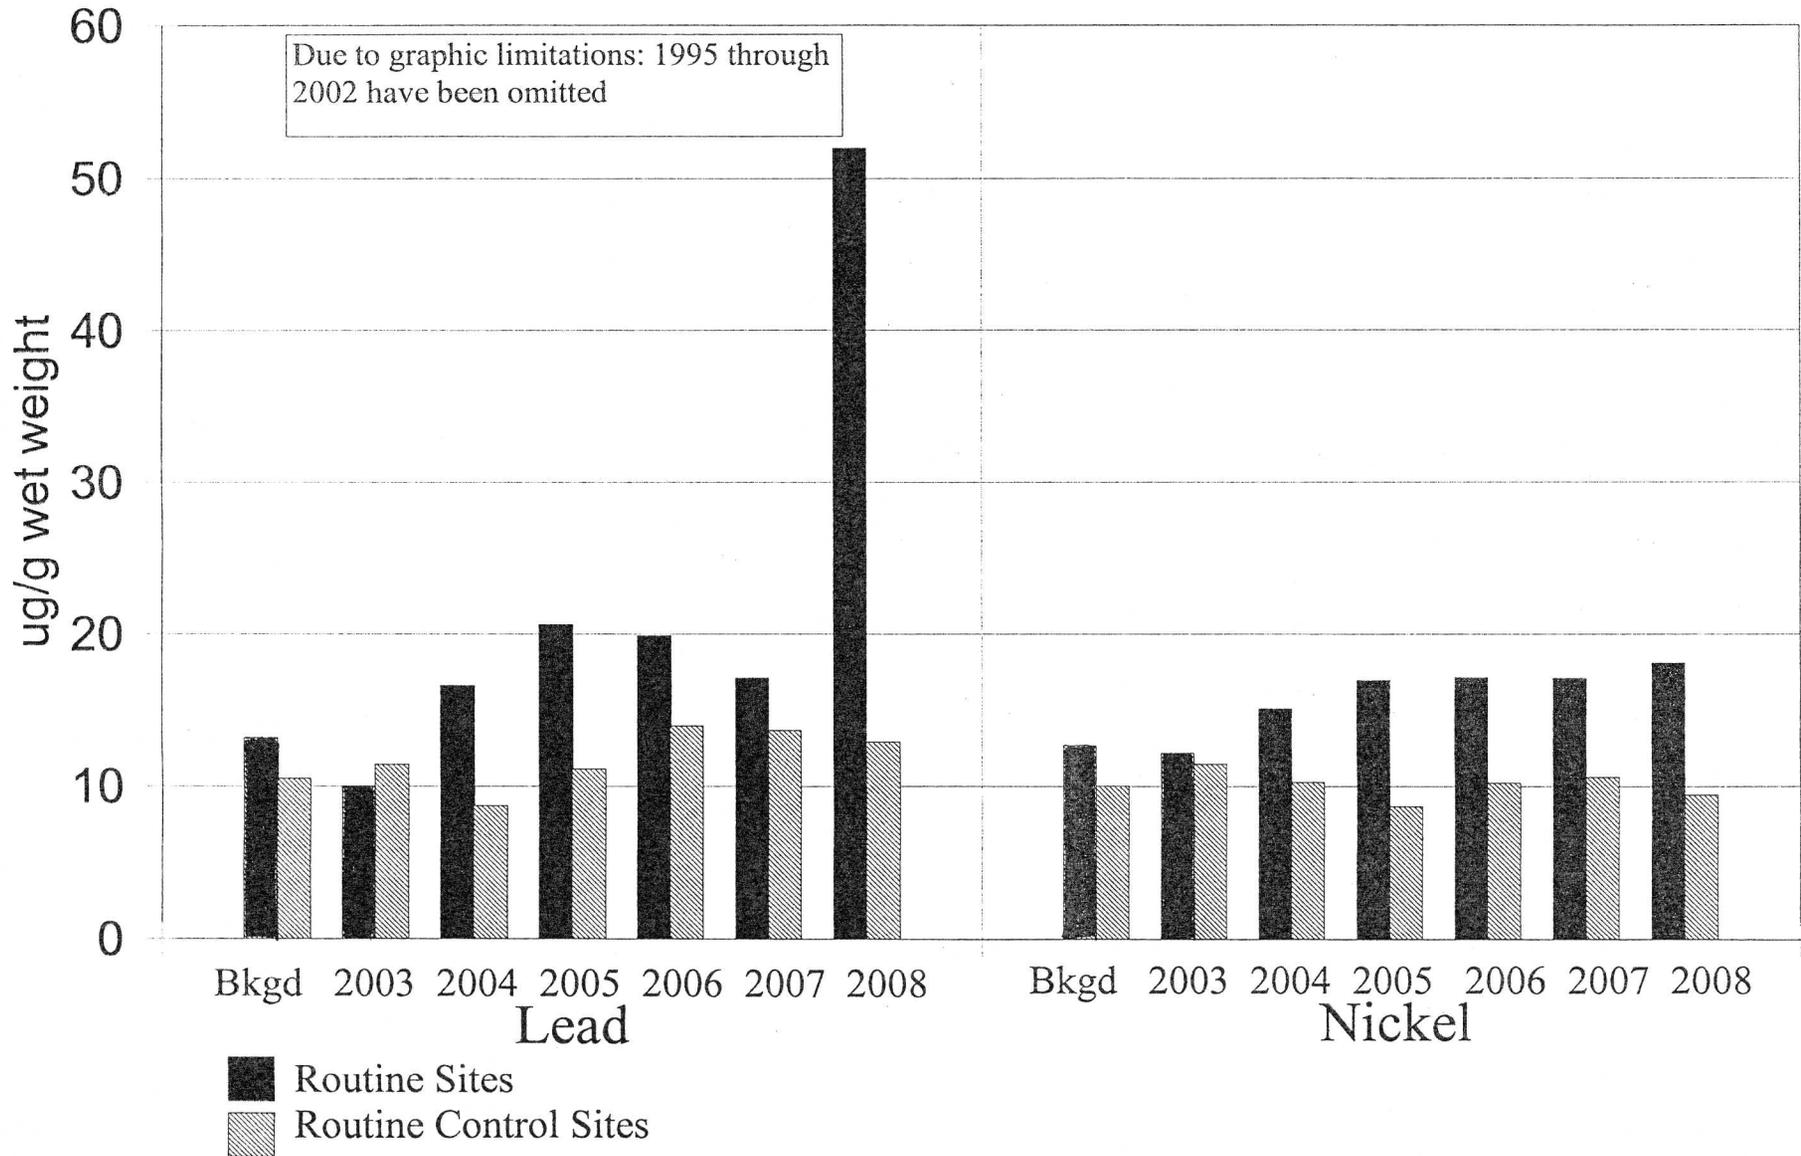
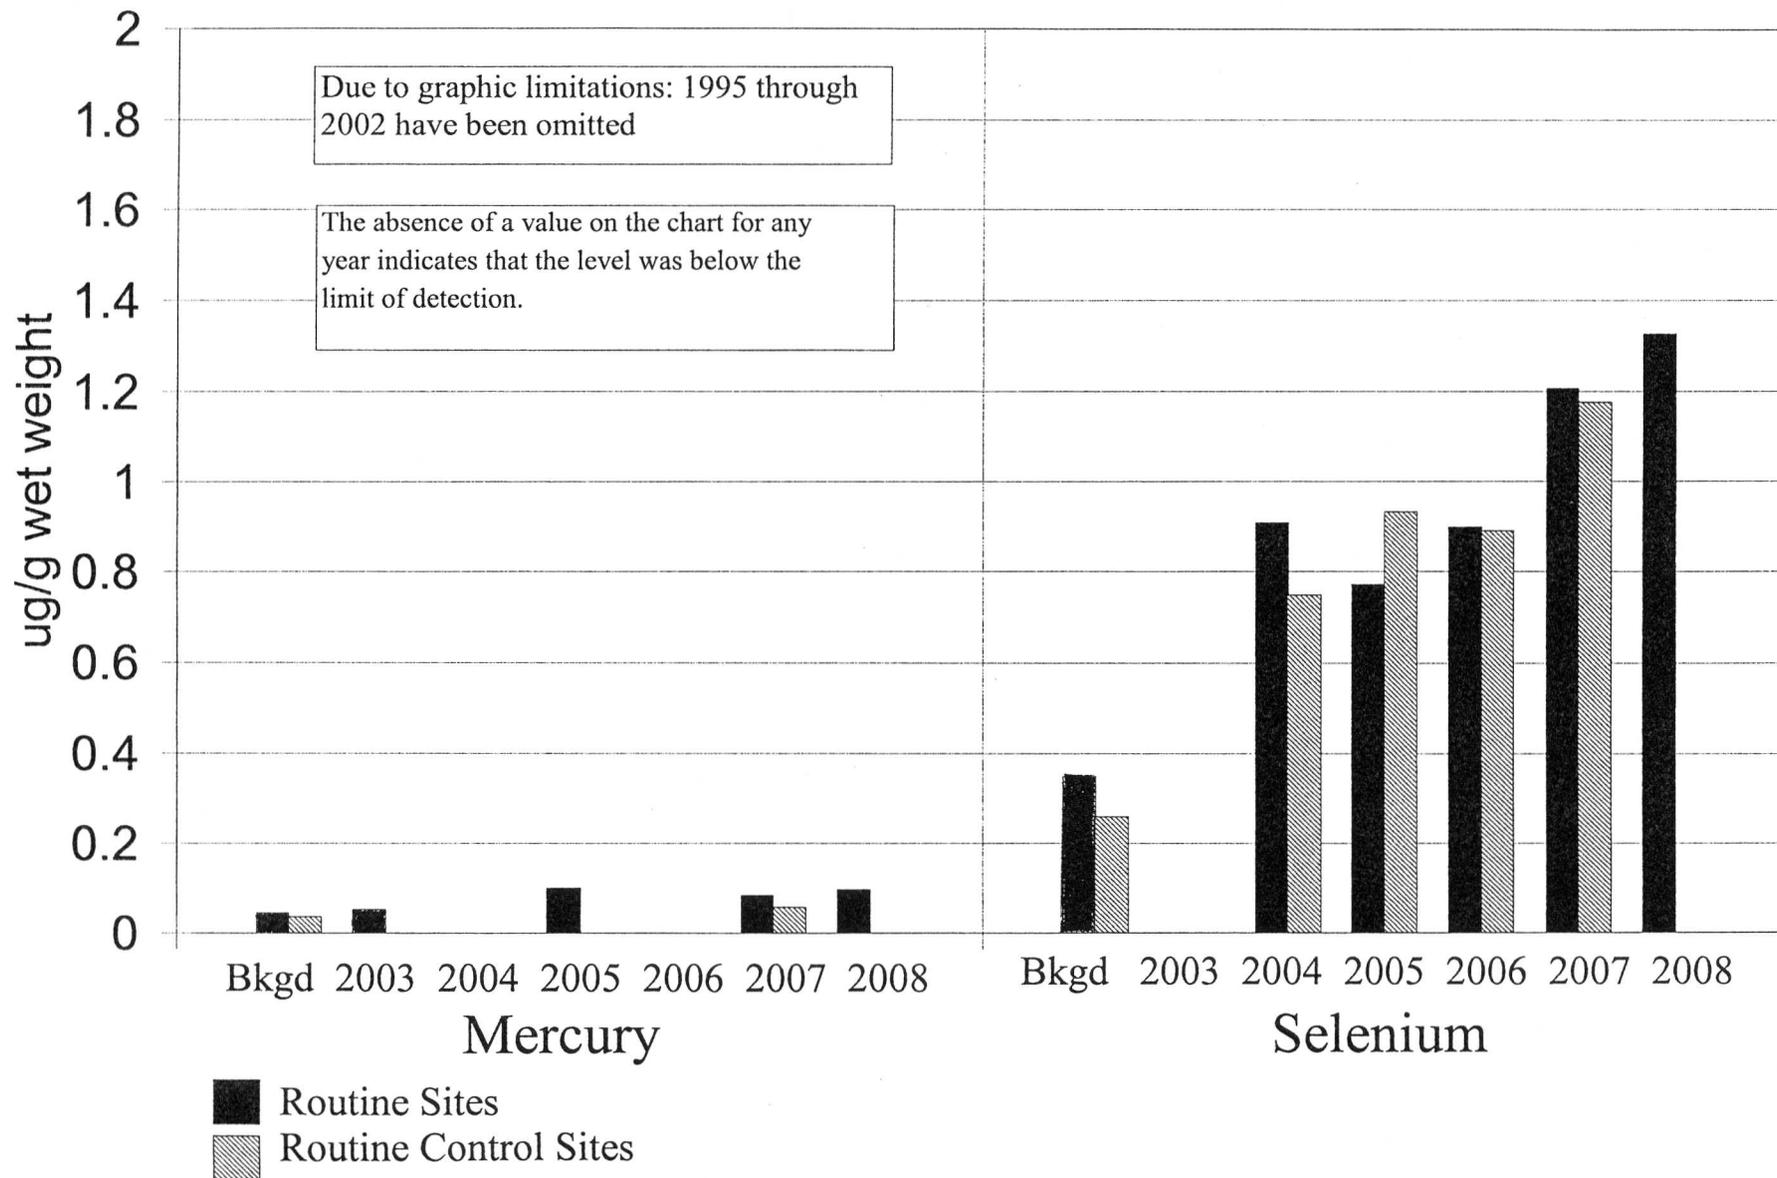
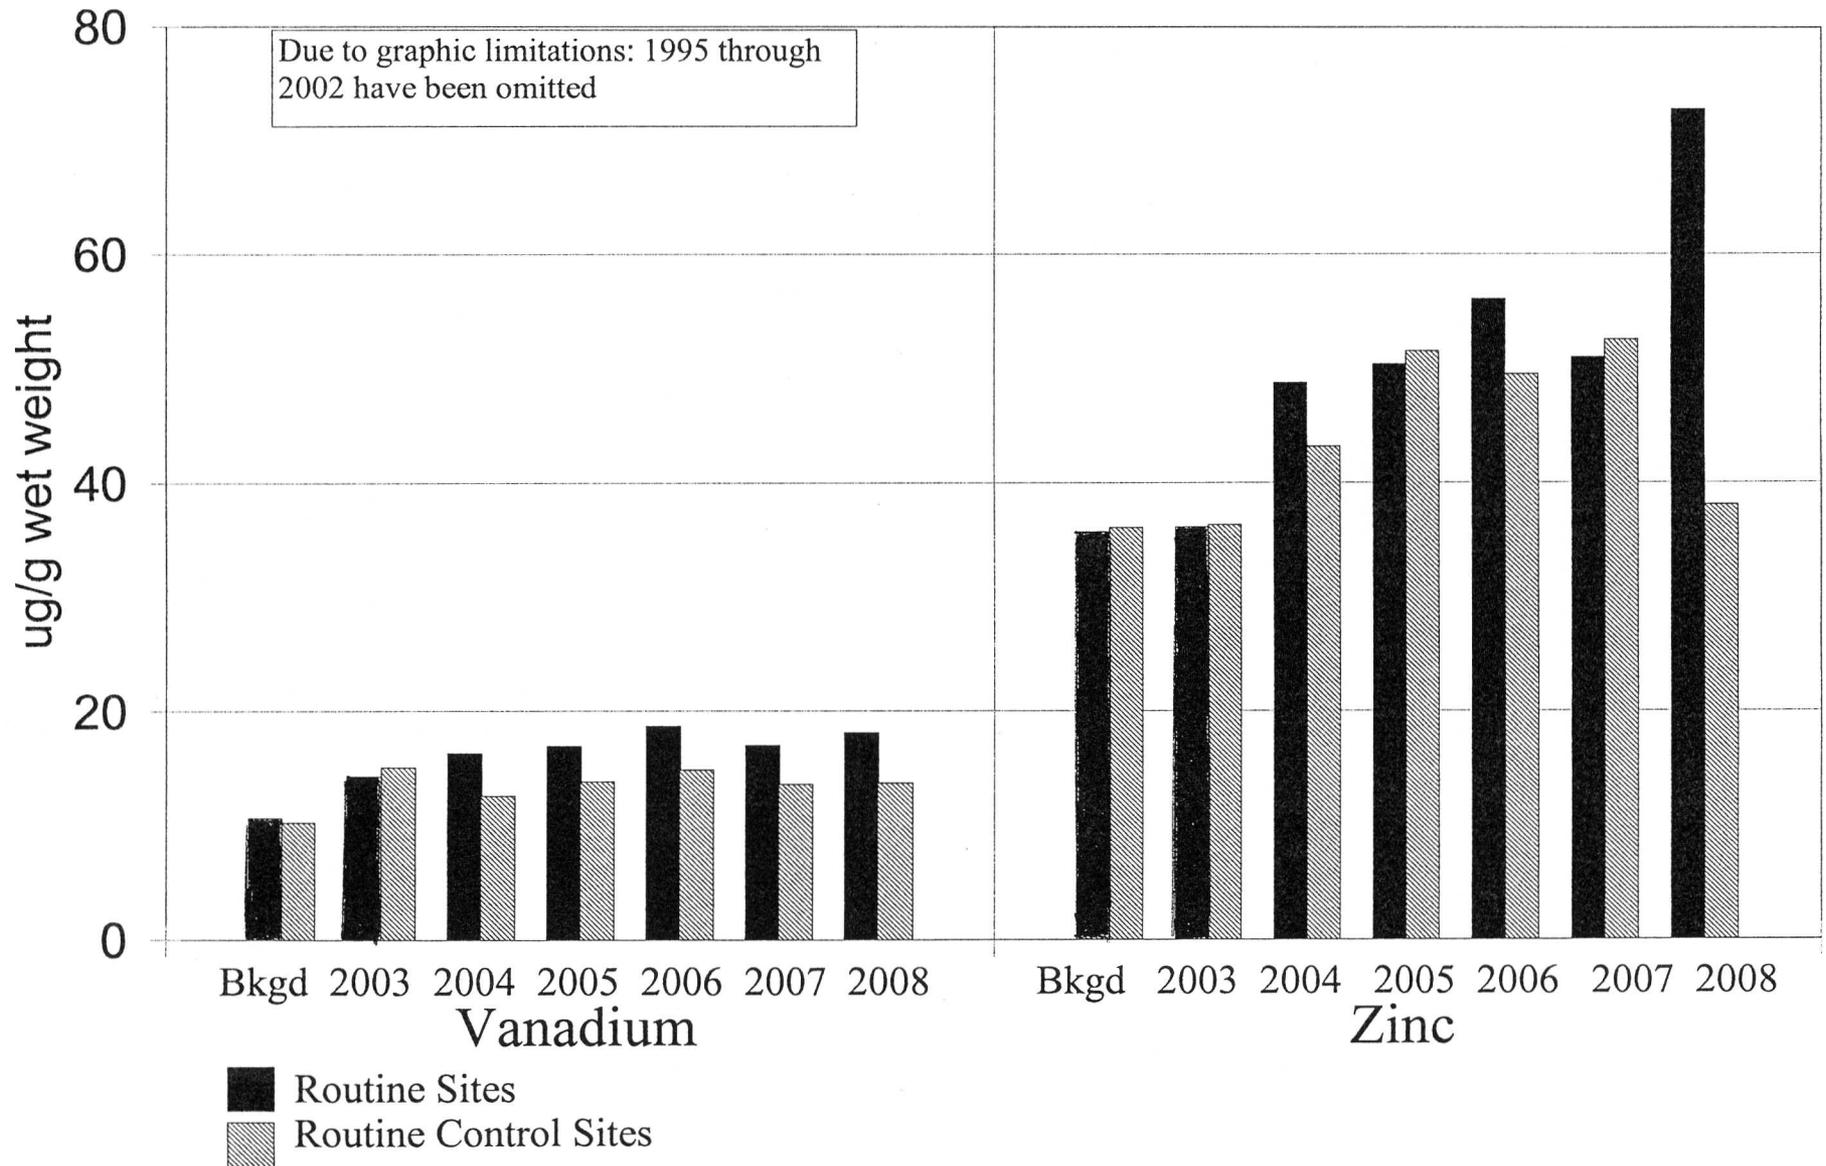
Attachment
C-1

Attachments C-1 and C-2 show the historical levels for the ten metals at the routine soil sites and ash route soil sites respectively. Due to the volume of data, the mean (average) of all routine sites and all routine control sites for each year is presented. The complete report includes all of the data for each site.

Comparison of Annual Mean Values Routine and Routine Control Sites

Metal results are compared to background levels, published national averages for urban areas and a statewide rural soil survey. Soil and ash are not homogeneous and can contain materials that can account for an occasional inconsistent result. Hence, a single elevated or depressed value will not be assumed to be indicative of a change at a specific site. Rather, the pattern of values for that specific element must demonstrate a statistically significant difference, which may be indicative of a real environmental change. In general, the metal results for soil fall within the expected range of values with the

exception of one sample. The fall soil sample at Jamesville Beach indicated levels of lead, mercury, and zinc higher than those historically found at the site. Since the 2008 data was atypical for this site and because the 2009 data was available at the time of report preparation, it is discussed in the detailed Soil Metals report. The 2009 sampling at Jamesville Beach indicated levels typical of historical data at this site. In general, the metal results for 2008 fall within the expected range of values for urban areas and demonstrate no significant variation from background levels.

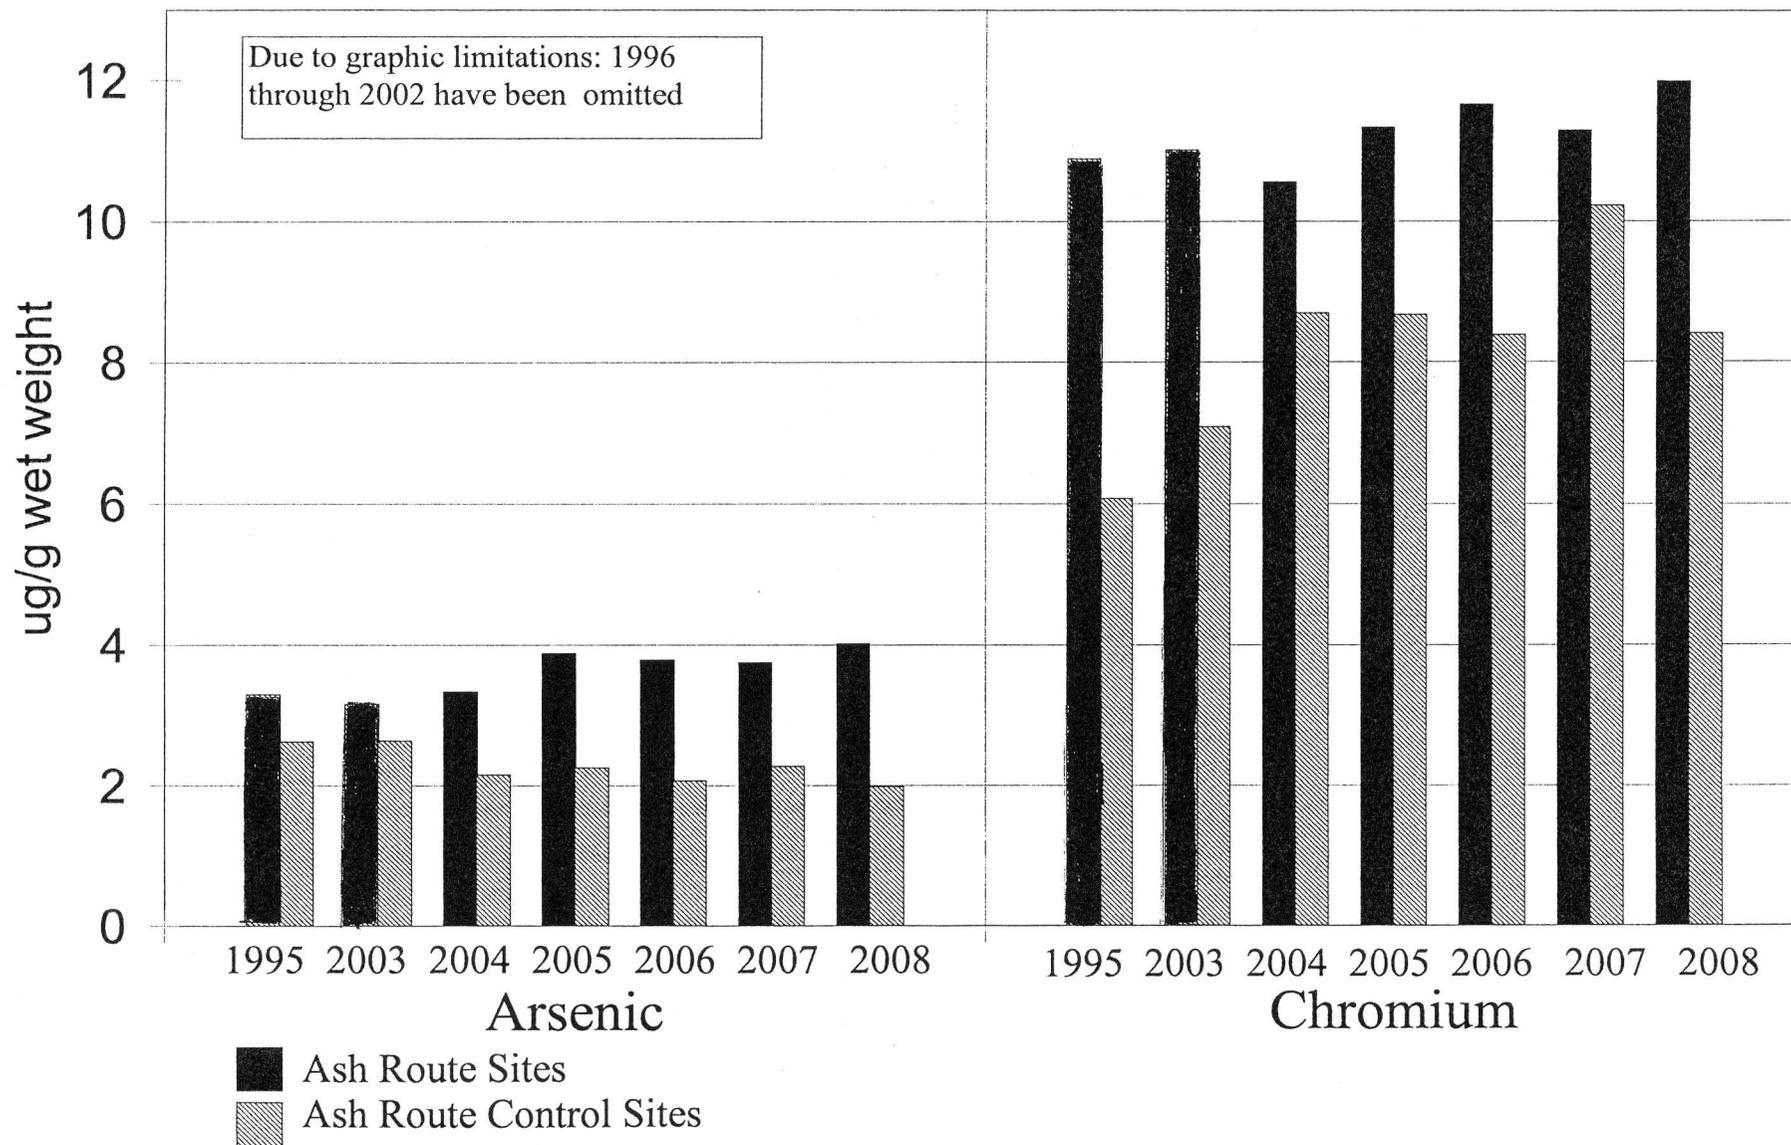
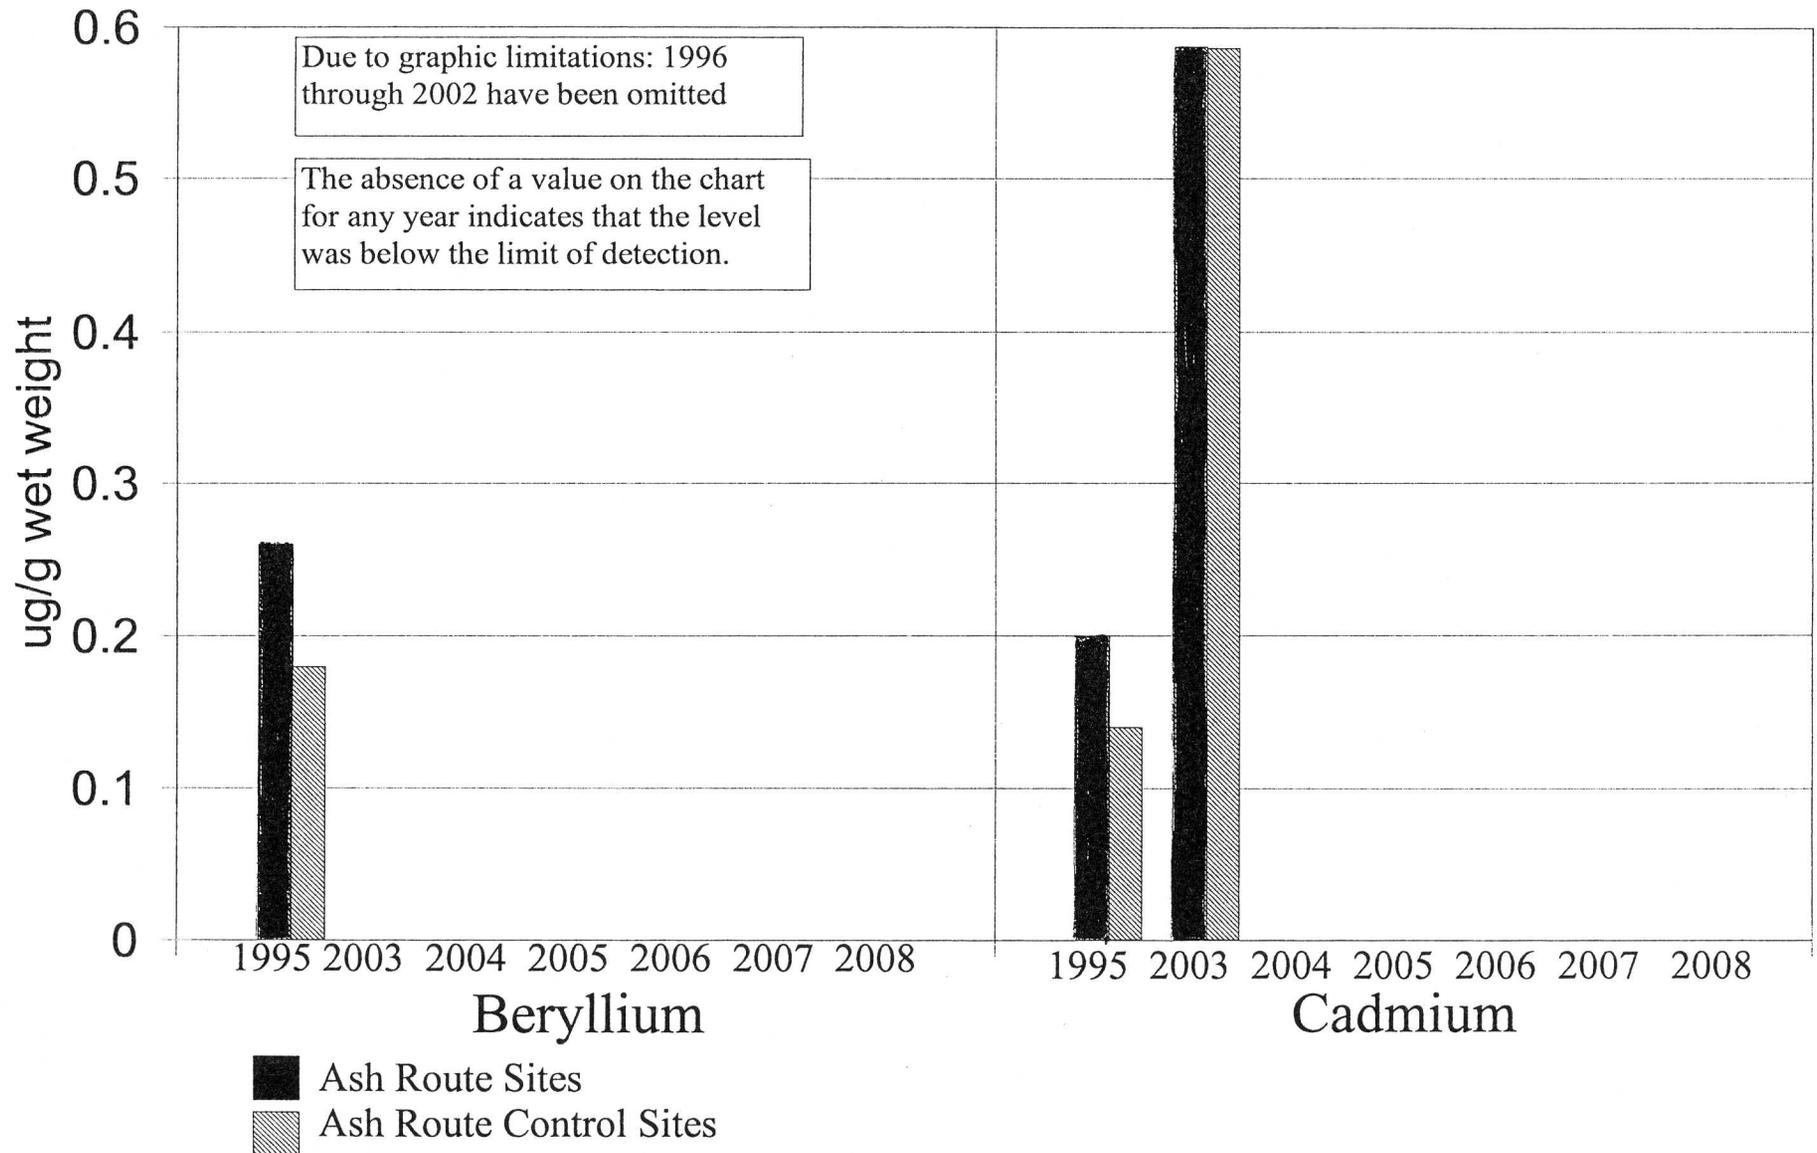
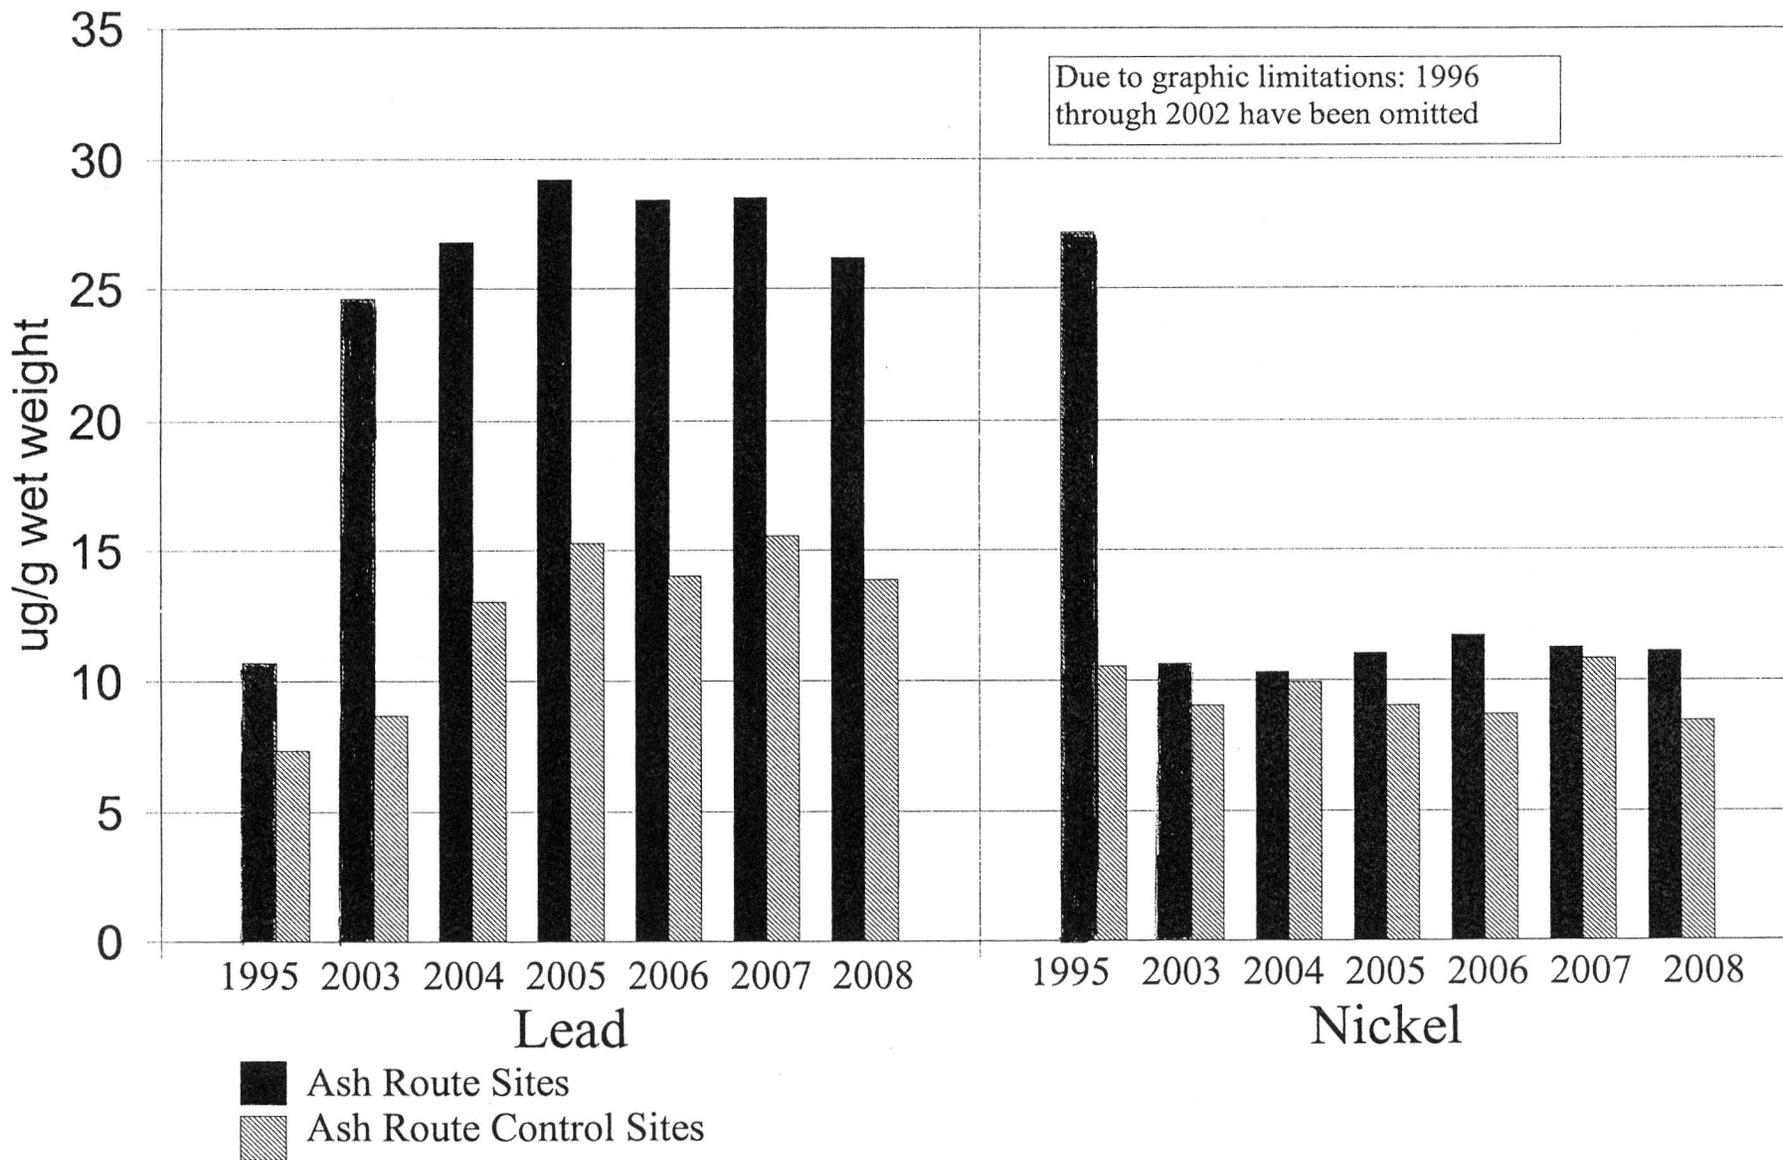
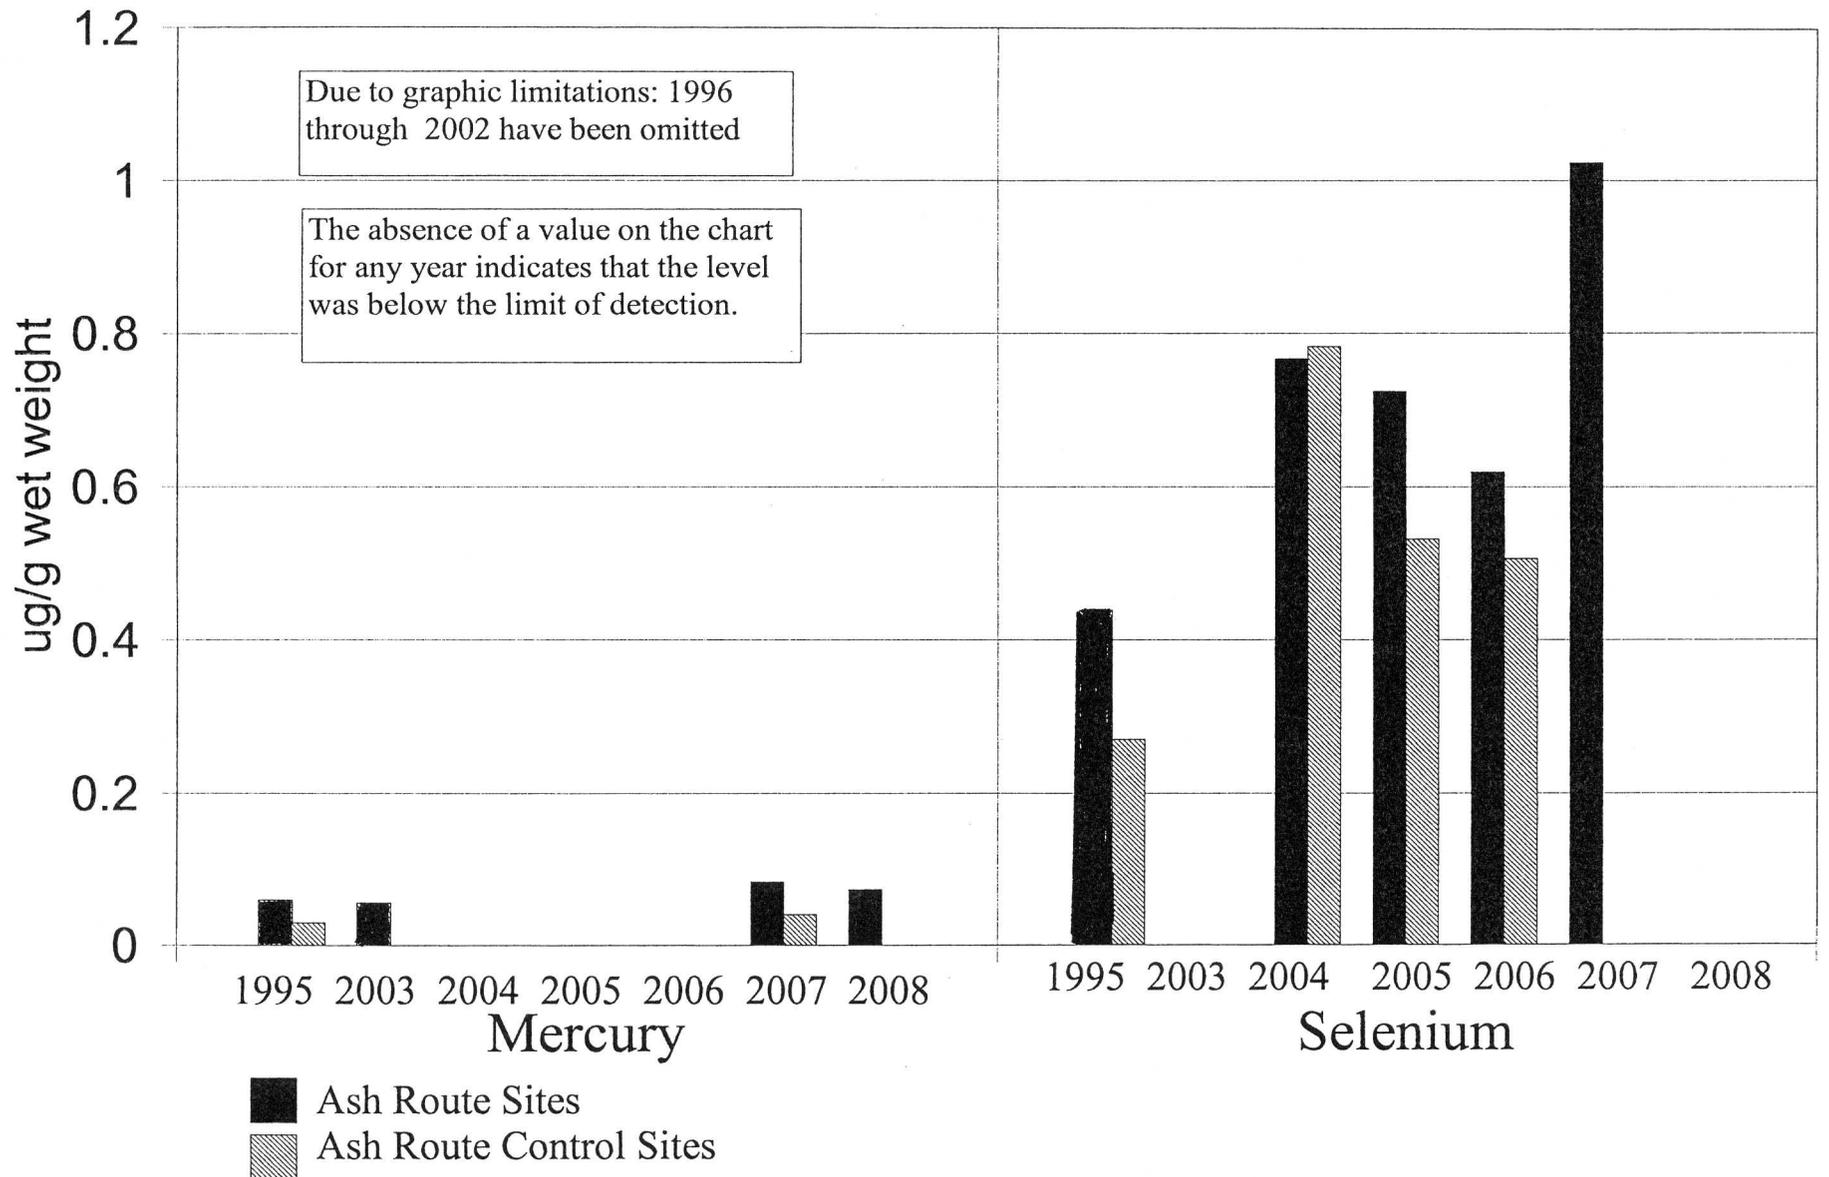
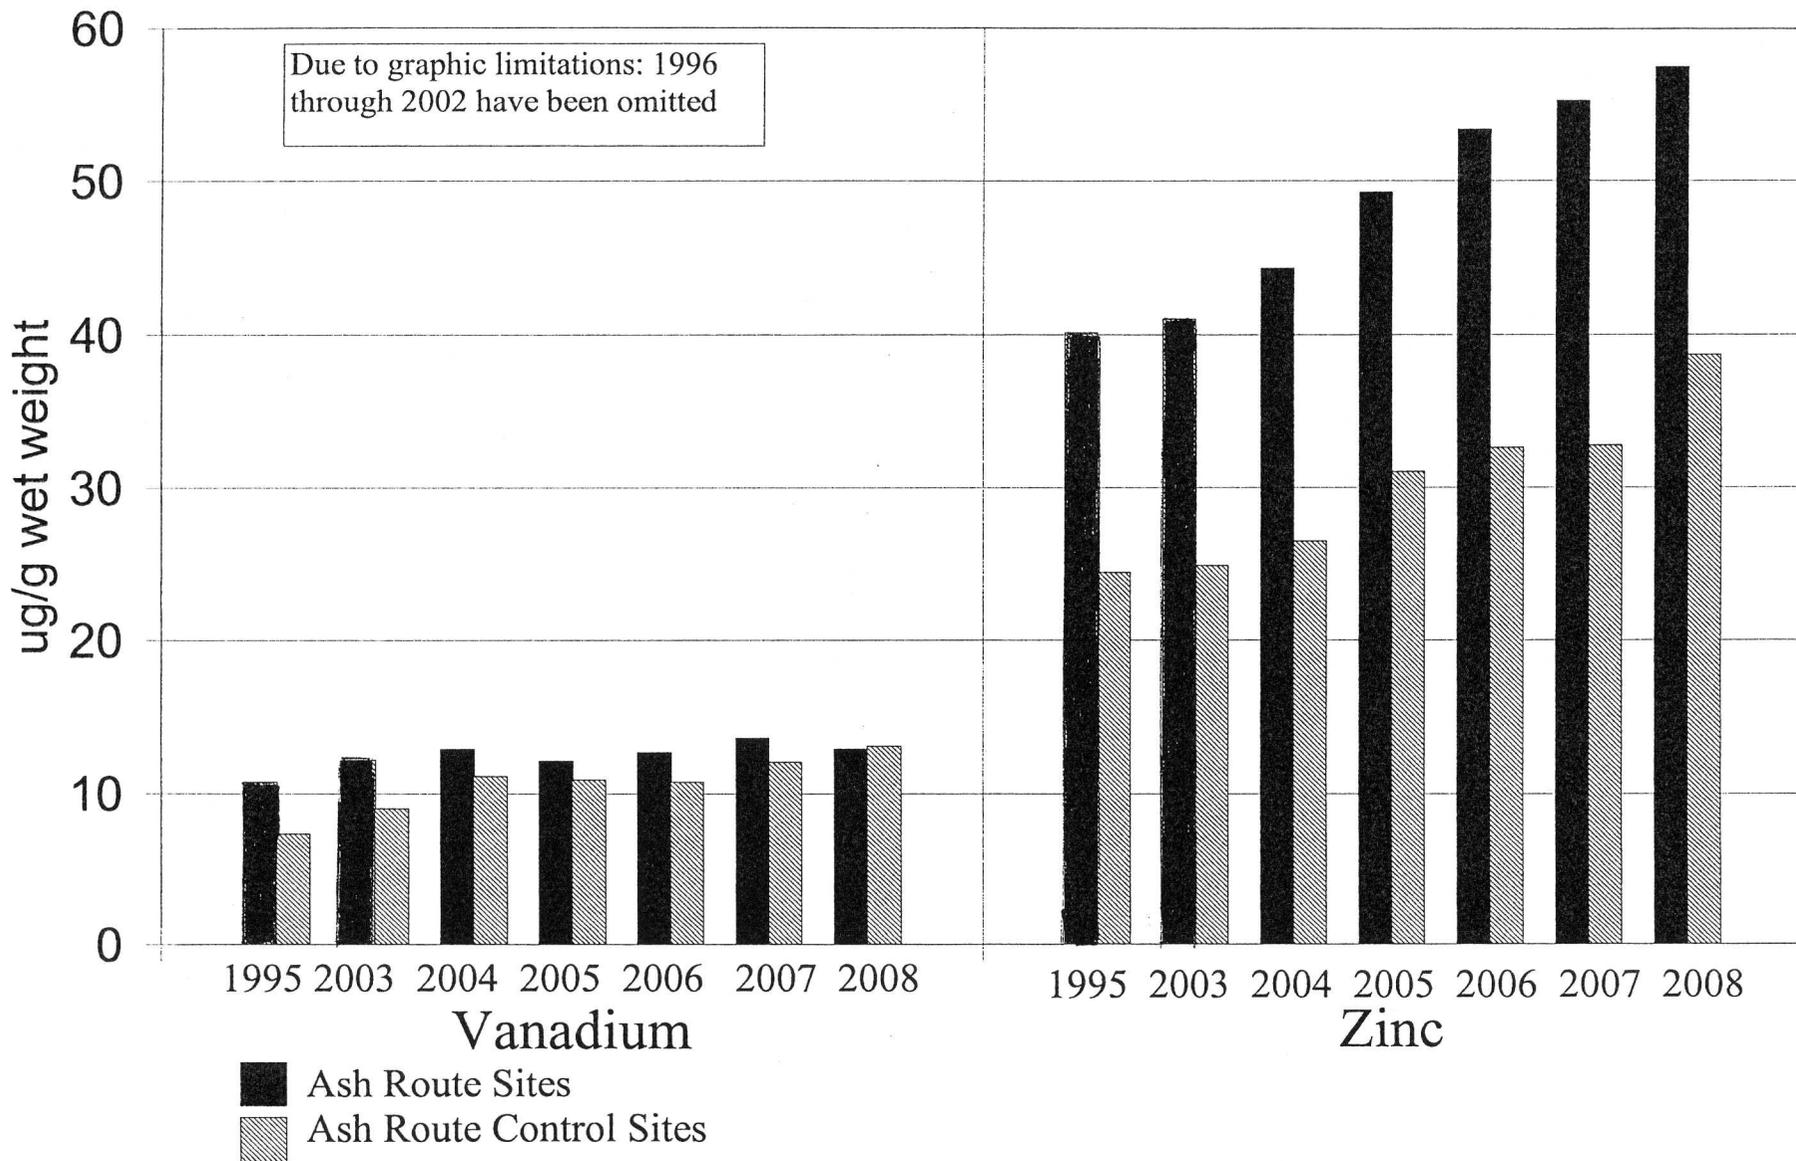
Attachment
C-2

Comparison of Annual Mean Values Ash Route and Ash Route Control Sites

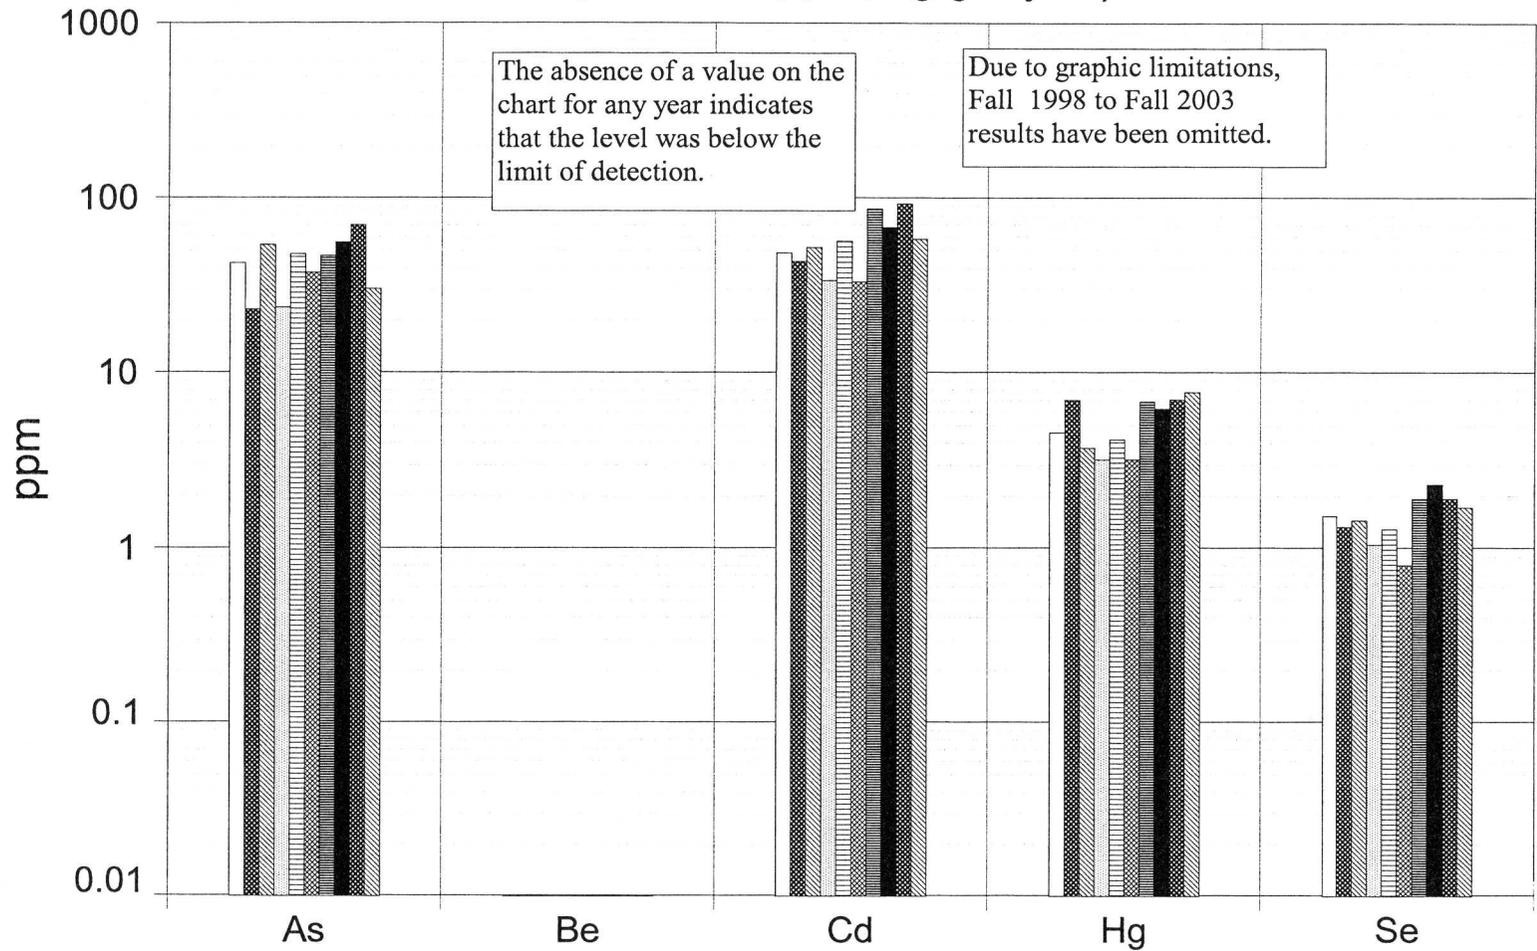
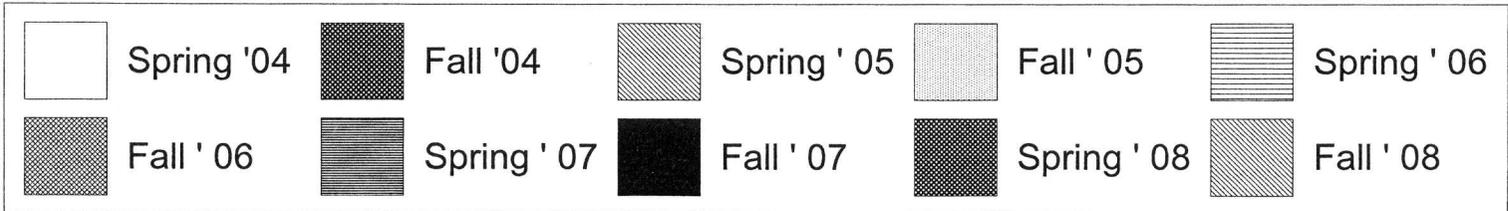
Attachment D shows the historical levels of the ten metals in ash.

Mean Values Ash Data

(Values in ppm; ug/g dry wt)

The absence of a value on the chart for any year indicates that the level was below the limit of detection.

Due to graphic limitations, Fall 1998 to Fall 2003 results have been omitted.
