Onondaga County Health Department

Incinerator Monitoring Program

2008 Summary Report

December 18, 2009

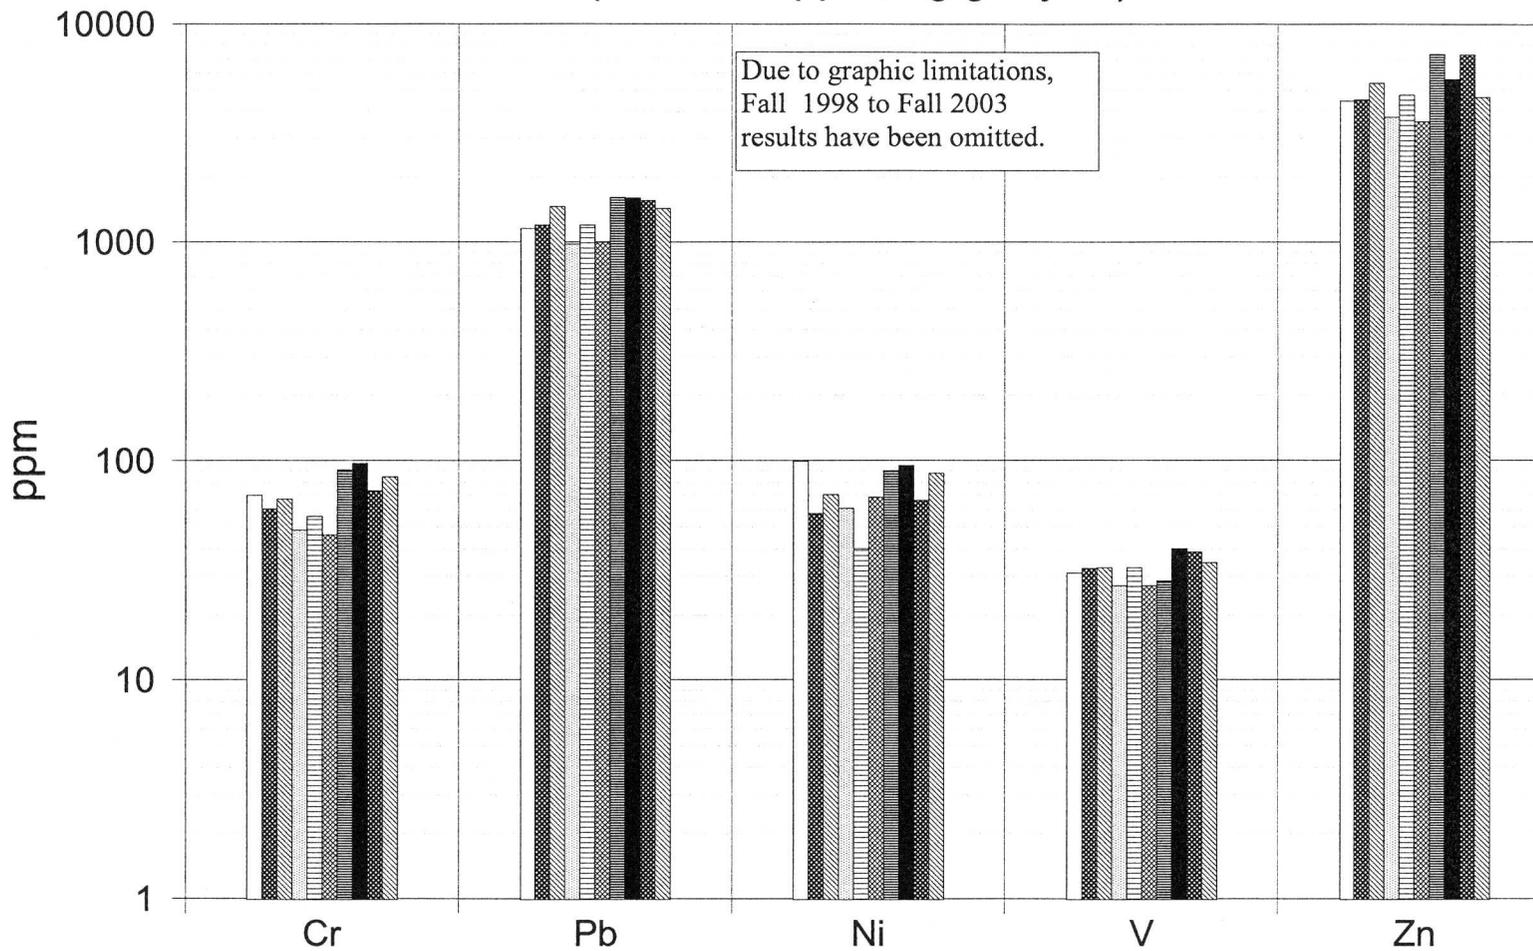
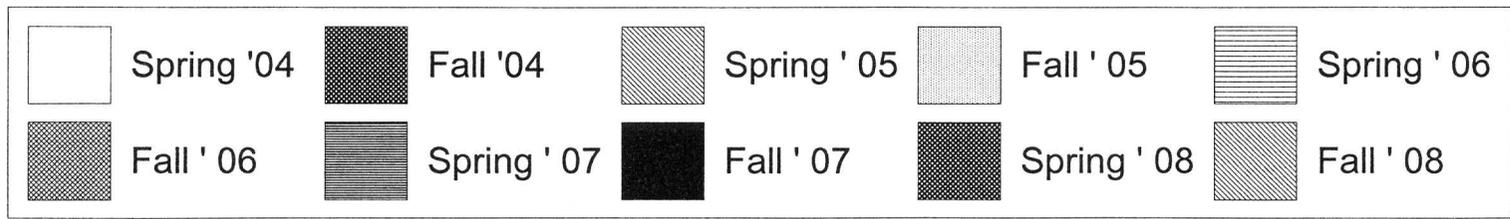
Mean Values Ash Data

(Values in ppm; ug/g dry wt)
